# HELEN C. WHITE LIBRARY FAÇADE EVALUATION UW Madison, Wisconsin

Submitted to:  
**Division of State Facilities**  
101 East Wilson Street, 7<sup>th</sup> Floor  
Madison, WI 53702

**Date: May 1, 2009**

**DSF Project Number: 07K3W**  
**A&O Project Number: 080362**

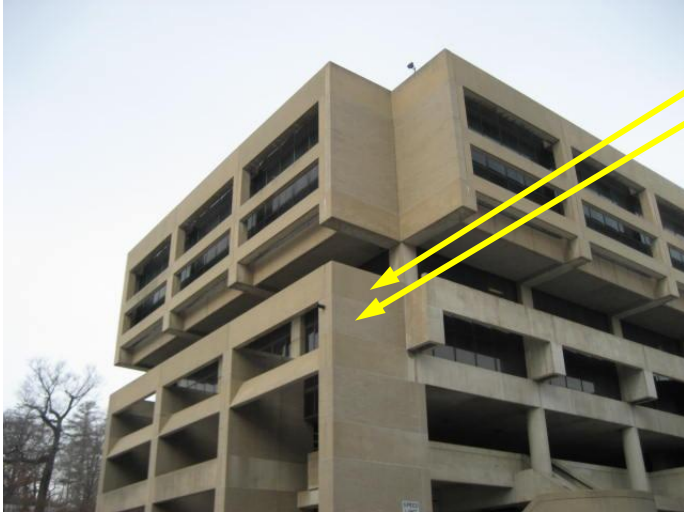
**Picture #1: South and east Elevation of Office Tower**

Precast concrete band  
Brick band

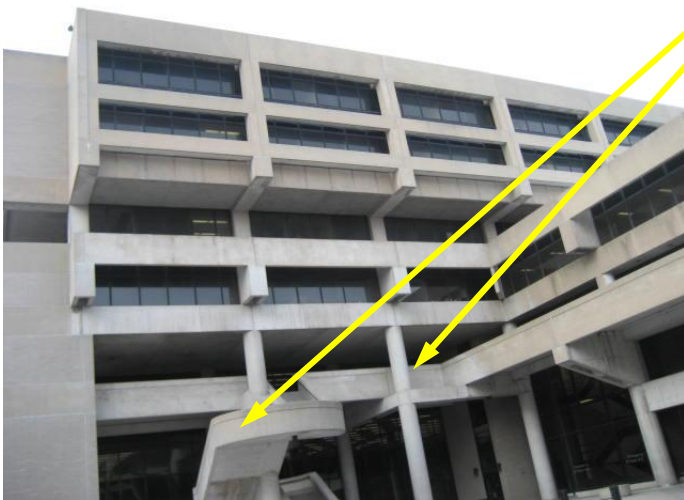
**Picture #2: East Elevation of Office Tower at South Entry**

6. The concrete stair at the west side of the entry plaza is shown on photo #2. The stair has been most likely heavily salted and relatively recently been covered with a urethane membrane. Rebar corrosion is evident on the underside of the stair slab. This has probably occurred due to water infiltration before the coating was applied. It does not appear to require further attention at this time. Other problems noted for this slab

- a. Cracks lengthwise in the stair treads: The cracks have penetrated the new coating. The solution would be to rout and caulk the crack and repair the urethane over the top.

- b. Drainage pattern at the intermediate landing seems marginal but is not suggested for revision since the urethane is relatively new.
  - c. A spall at the intermediate landing level at the top surface of the concrete slab. The spall has damaged the urethane coating.

Cast in place concrete stair  
Walkway at third library level

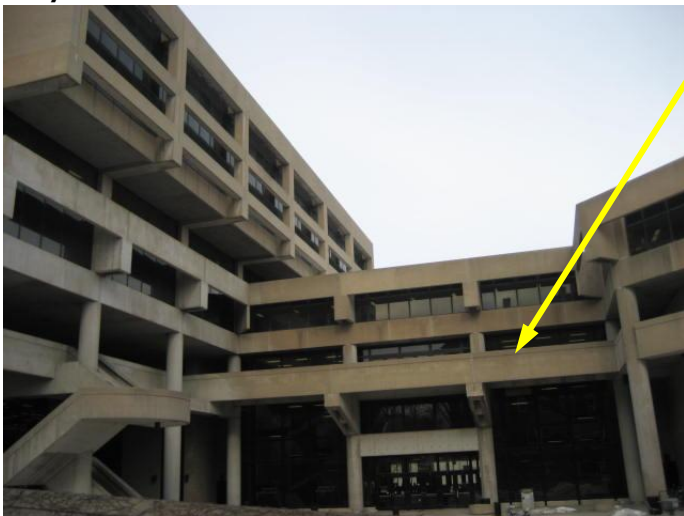
**Picture #3: South Elevation Main Entry to Library School**

4. The walkway at the third library level. The walkway rings the courtyard on west thru the east side and extends to the southeast stair tower. Please refer to photos #2 thru 5. The west side and central portion of the walkway is constructed of precast planks running with the long direction of the walkway. The east side is poured in place concrete. Except for the panel shown in photo #30, the plank portion of the walkway is in good condition, especially considering the salts being used for de-icing. The caulking between precast panels has delaminated in certain portions and is in need of replacement. The water stains from the leaking caulk can be seen in the underside of the slabs.

Walkway at third library level

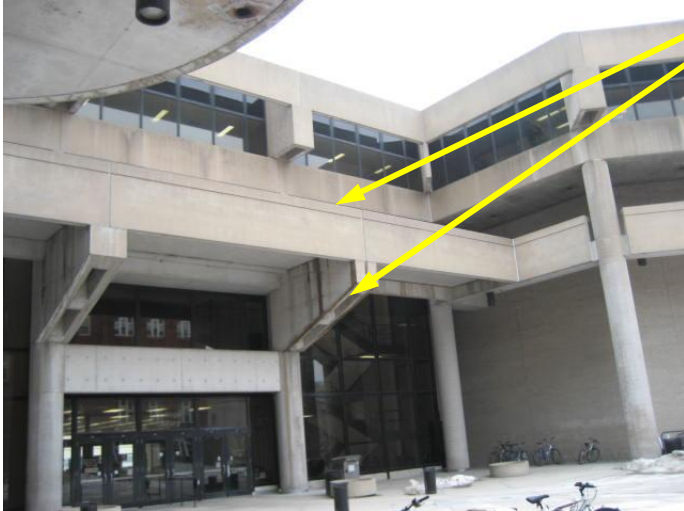
**Picture #4: South Elevation- South Entry**

Walkway at third library level  
Concrete supports for walkway The stains noted are from leakage in the joints of the precast walkway slabs.

The poured in place walkway on the east side is in much worse condition than the precast portions. Modern day techniques of significant slope, epoxy coated rebar and higher density concrete were not used in the original construction and thus more effort must be expended in continuing repairs. Shrinkage cracks in the floor panels have been caulked but are in need of re-caulking. There are delaminations in the slabs. We have not done a chain drag survey for this slab as it was outside the scope of this report. Delamination and caulk repairs followed by a urethane coating would be desirable to extend the life of this slab.

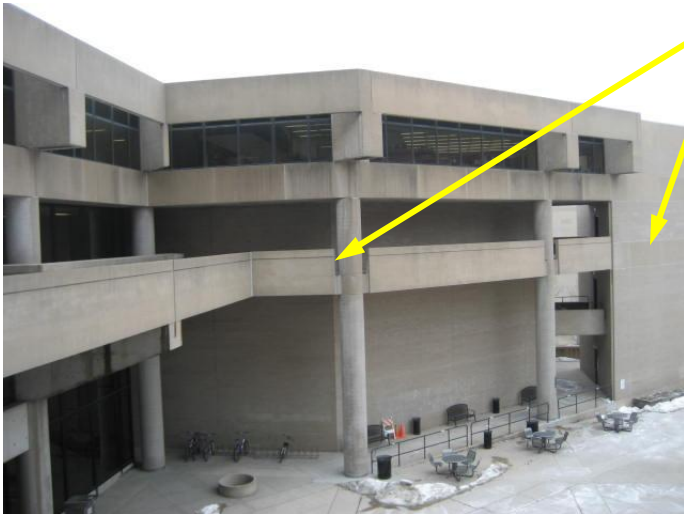
**Picture #5: West Elevation of East Wing Near Main Entry**

Walkway at third library level  
Southeast corner stair box

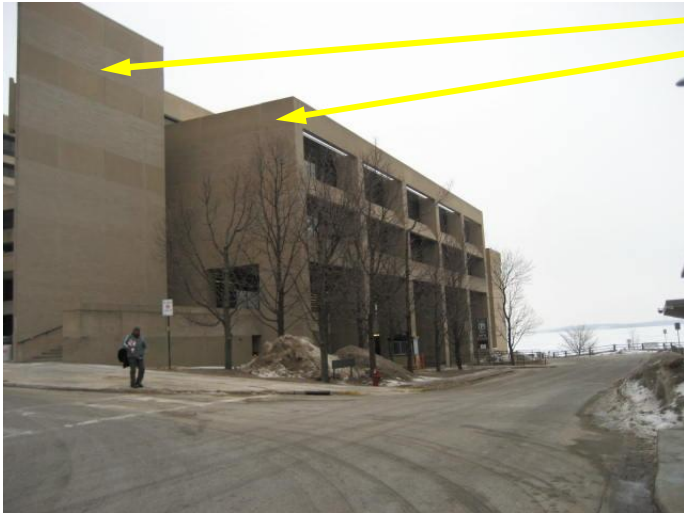
**Picture #7: East Elevation of Library School looking north and abutting Park Street**

Southeast stair box  
Area of investigation for parapet panel alignment

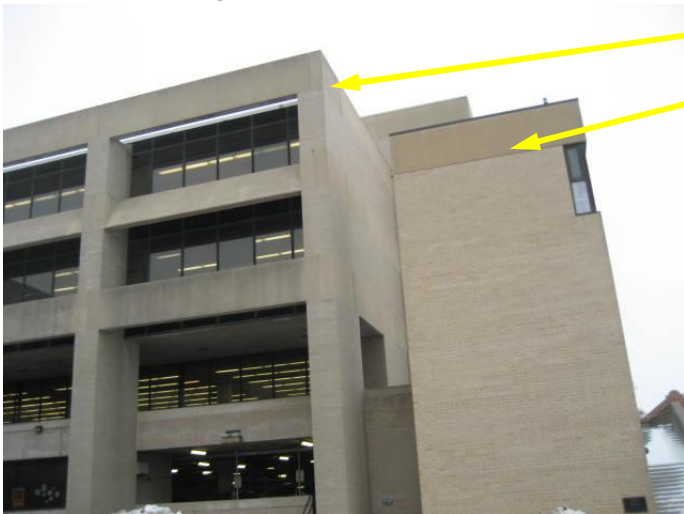
**Picture #8: east elevation of library School viewed from park Street**

The same condition occurs on the north wall, south of the signal tower and the same opinions hold there.

Matching parapet misalignment corresponding to the condition at the south wall Signal Tower

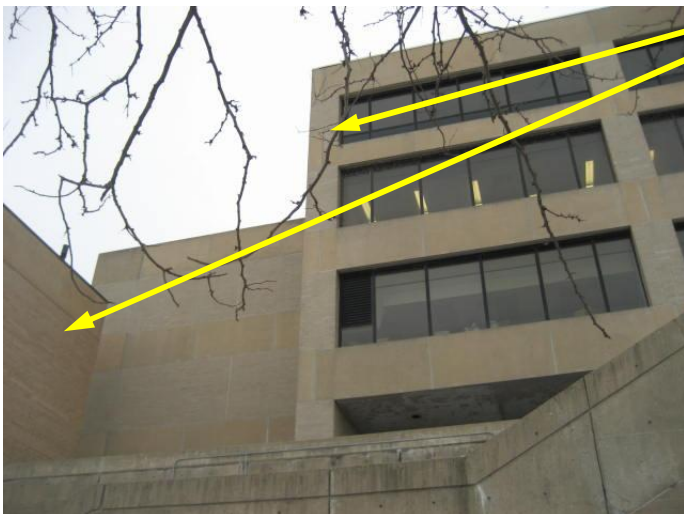
**Picture #9: North Elevation East End**

3. The north elevation of the building adjacent to office #4232 (fourth level east end of the library school building) has a crack as shown on photo #9. The crack extends from the end of the intersecting precast panel horizontally toward the window and into the exposed brick inside office #4232. This is most likely a result of initial shrinkage in the precast panel and exacerbated by thermal movement. There are no other instances where this occurs in the building leading to the idea that the repair would be simply re-pointing of the joint with matching mortar. There does not appear, from the ground, to be any broken bricks thus making the repair fairly straight forward.

Cracked brick at office 4232 Signal Tower

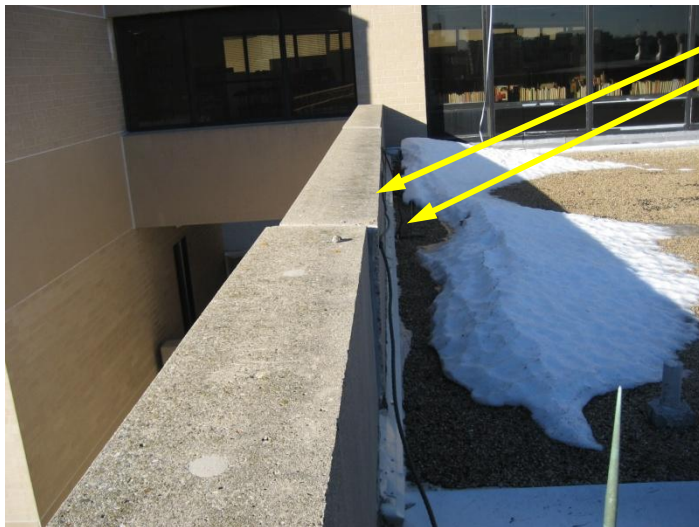
**Picture #15: Misaligned parapet-south wall, east wing**

- I. Photos 15-17 show the location of a precast parapet panel misalignment. This occurs at the library school east wing at the south wall. A similar condition exists along the north wall at the companion

position. This area was subject to an evaluation using a boom truck for closer observation. The caulk at the head joints of the panels was removed to observe the building connection condition which the original design drawings showed to exist between panels. There was no connection found between the panels and the concrete beam as the original drawings had shown. The support for the panel is thus considered to occur where noted in photo 17 where the upper and thicker portion of the panel overlaps the concrete roof slab. There was no attempt to expose the condition since it was in early February and removal of the roofing membrane was not desirable with the temperatures present at the time.

Misaligned parapet panel  
Corner panel.

There is no repair anticipated or cost estimate made for this condition.

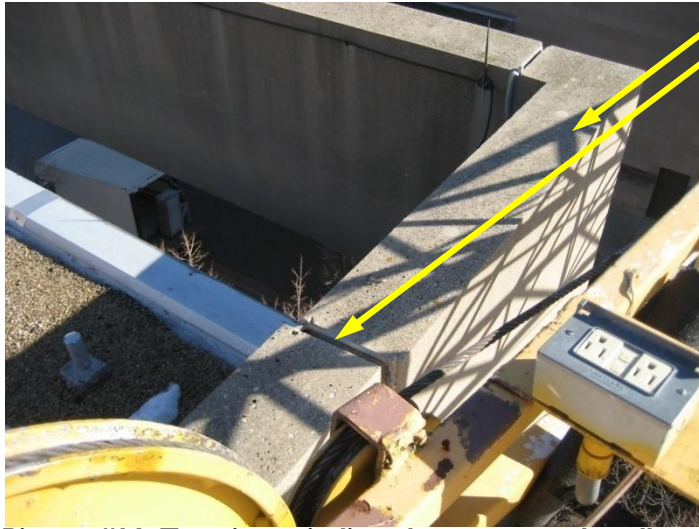
Picture #16: Top view misaligned parapet-south wall

Corner panel  
Misaligned panel joint

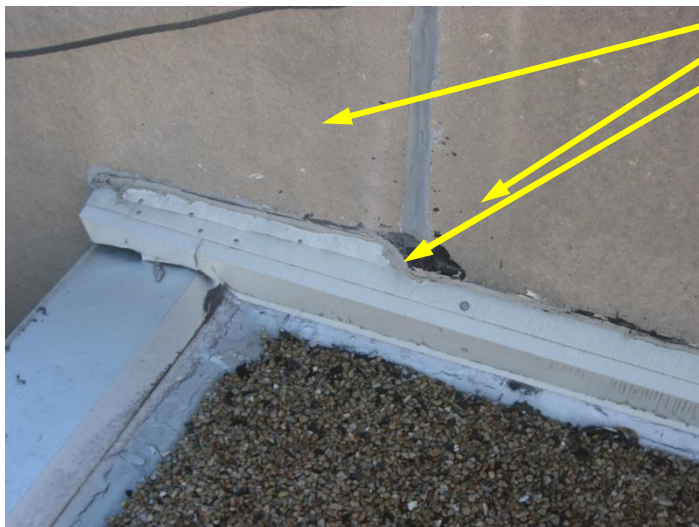
Picture #17: Flashing behind misaligned panel

Corner panel  
First Interior panel  
Misaligned counter flashing. The support for the precast panel probably occurs behind the counterflashing where the panel overlaps the concrete roof slab.

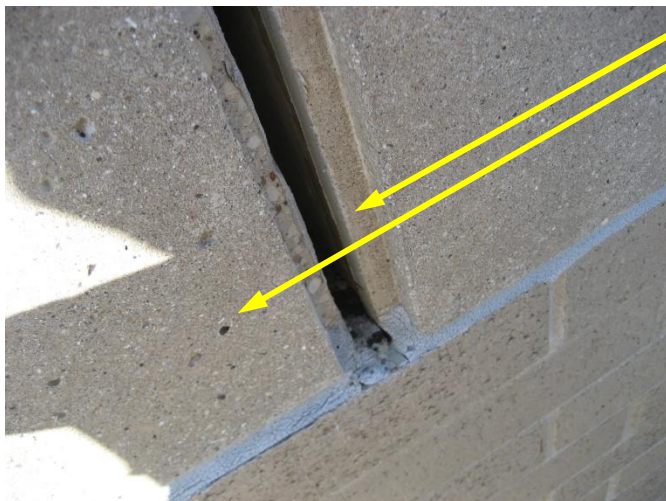
Picture #18: Head joint, misaligned panel, south wall

Using a level, the corner panel was found to be plumb and square with the wall. The first interior panel was then judged to be the panel which was out of alignment. This panel had been field modified as shown on photo #18. The east end of the panel had been cutoff in the field as evidenced by the rough cut of the head joint surface and the lack of the caulk recess cast into the panel. The panel as supplied to the job site was apparently too long. Using a level and a straight edge the panel was found to have a warped outer surface. The panel corners reasonably flushed out with adjacent construction at the two bottom corners and the top corner at the west end. The top corner at the east end was inset about 1" relative to the corner panel thus indicating the warped condition. The top elevation of all the precast panels were consistent along the parapet indicating there was no loss of vertical support. Evidence from the caulk indicated this misalignment existed at the point 10-15 years ago when the re-caulk was done. Based on the counterflash (photo#17) the panel misalignment existed at least when the building was re-roofed. Thus it is concluded that the best evidence is that the first interior panel was probably placed in this position originally. The support for the panel could be exposed by removing the roofing for final verification of this opinion, if desired.

Corner panel  
First interwork panel off the corner

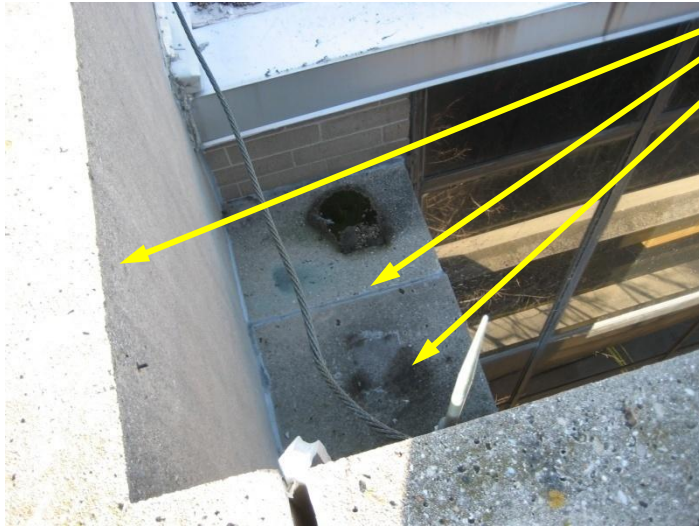
**Picture #19: Top view of pier**

Corner parapet panel  
Concrete cap over pier  
Probable area of connection for spandrel panel

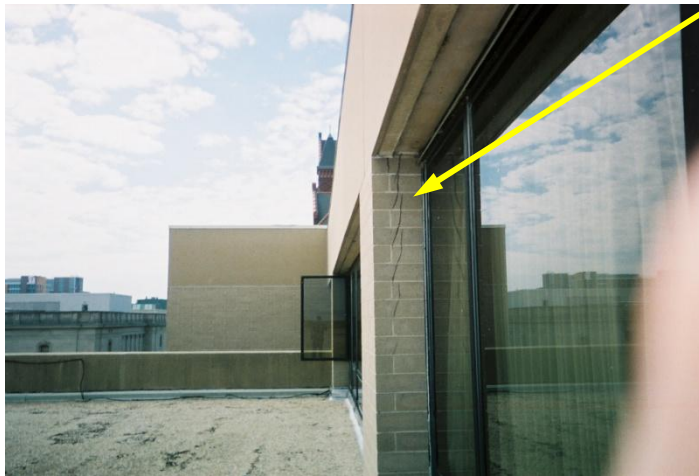
**Picture #20: Low Roof at Library School**

2. Along the juncture of high and low roof at the library school (grid 9 in original building drawings) there are four intermediate masonry covered piers as shown in photo #20. The first and second interior piers from the south end have vertical cracks in the brick as shown in the photo. There is also some cracking on the east exposed face of

the pier although they are hairline. The north two piers do not have this type of cracking. The piers consist of brick built around the concrete columns. The east face of the pier bears the weight of the precast spandrel. The brick returns to the interior side of the column and is exposed within the room. It is the writer's opinion that the brick has been cracked by the shrinkage and thermal movement of the precast spandrel panels. This is evidenced by the vertical hairline cracks on the east face of the pier and by the horizontal offsets in cracks in the north and south faces of the piers.

Cracked brick pier at the junction of the high and low roof at the east side of the building. Referring to the existing building drawings this would be along grid 9.

The repair proposed is complicated by the fact that the brick is partially exterior and partially interior and any repair would involve removal of the windows on either side of the pier. The desirable solution would be to remove and replace the cracked bricks. It is probable that no extra original bricks are available but that a possible match could be achieved as was done at the signal tower. The precast spandrel panel would be shored and eventually set on a hard plastic bearing pad on the brick. This would allow some movement in the panel without distress to the brick.

The easy solution is to simply caulk the cracks to avoid water entry to the pier and avoid the potential of freeze damage at the base of the pier.

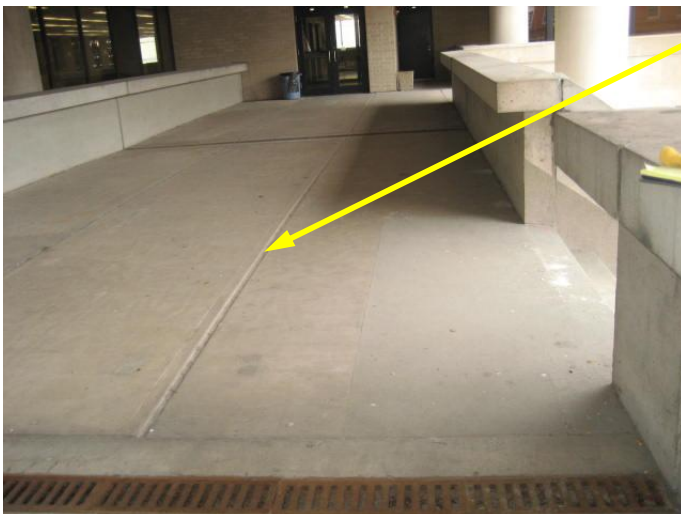
**Picture #21: West Side Walkway**

West walkway with precast panels. Arrow points toward the caulk joint

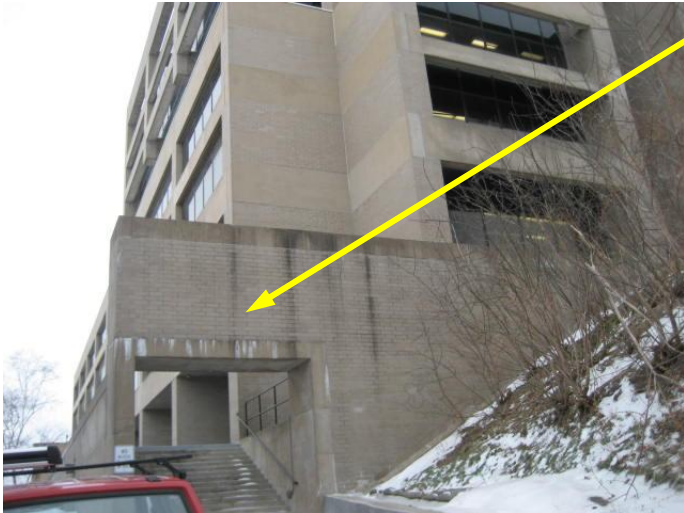
**Picture #22: Entry wall at Northwest Corner**

5. The accent wall at the northwest corner of the building has evidence of a leaking coping. This wall forms the west end of the north walkway. This condition is shown on photo #22. Water stains at the concrete beam over the walkway are indicative of a leaking coping. There is no visible drip edge under the coping and thus it is assumed there is no flashing under the coping. It is felt the coping leaks along essentially the full length of the wall even though the evidence of leakage only occurs where the beam exists. Because of the difficulty in removing the cast in place coping, we are proposing the wall be coated with a silane sealer to slow down the deterioration. Ultimately there is nothing to do with this wall other than to reconstruct it to modern water resistance standards. We are not proposing this to be done at this time as the wall still has integrity. At some point in the future this section of wall system will need to be replaced.

Section of wall with leaking coping. The stains on the lower poured concrete beam indicate the passage of water thru the wall.

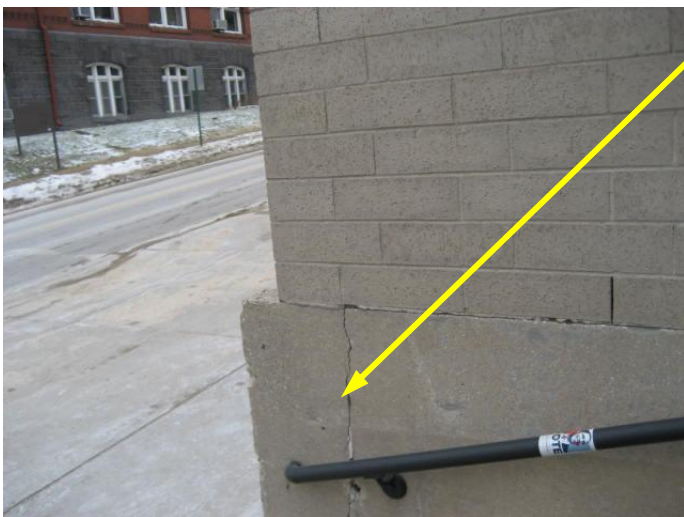
**Picture #24: South end of Southeast Stair**

Crack in foundation wall

7. Photo 24 shows a crack in the foundation wall at the southeast stair. This should be repaired by routing and caulking.

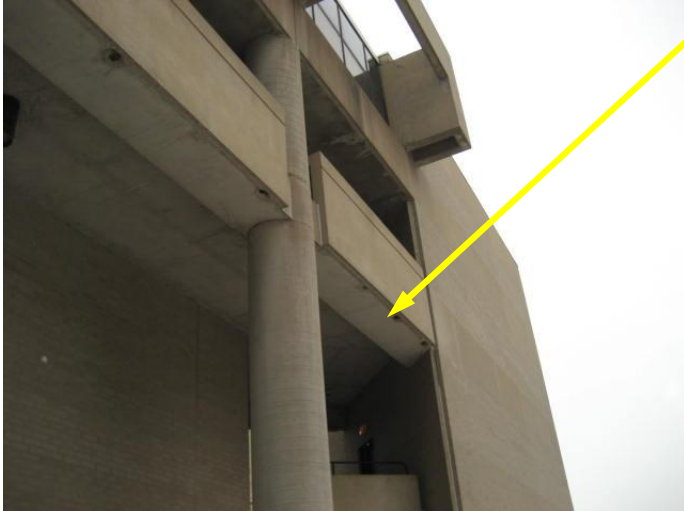
**Picture #25: Underside of East Walkway**

8. Photo 25. Rusted spandrel connectors on the underside of the east walkway. The steel connectors have rusted due to the corrosion proceeding on the walk way slab above. At this point they do not appear to have lost significant cross section but this observation is made from the ground only, not from a close up view. This is further evidence of the desirability of resolving the water issues at the walkway. The spandrels tended to block the escape of surface water, causing damage to the spandrels and the slab itself.

Rusted concrete spandrel connectors

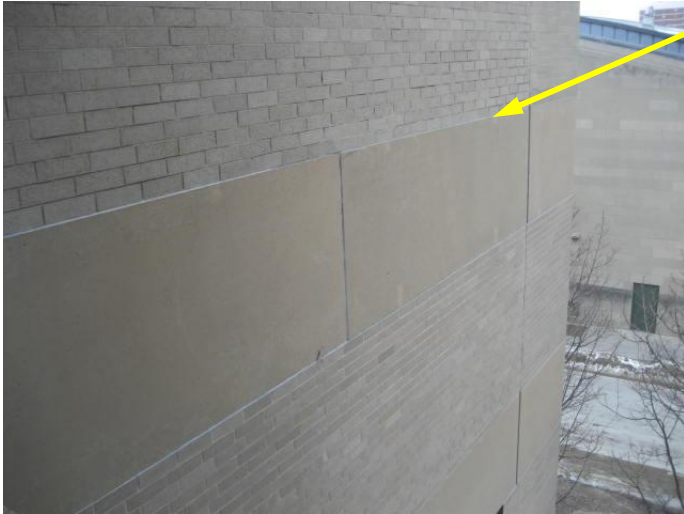
**Picture #26: South Wall at the Library School**

9. Photo #26 shows a typical condition of a precast panel built within the brick wythe. The backup for the wall is typically concrete block. The precast panels share the brick width. There is no drip edge evident and the belief is there is no flashing at the precast panels and back to the CMU wythe. Weep holes were not observed to be present in the brick as a means of water exit from the cavity. Thus any infiltration will collect at the base of the wall and potentially cause damage to the wall. The cost to cut in weep vents has been included in the estimate. The costs provided assume weeps are cut into the bottom of each brick wall at the elevation of the top of the foundation wall.

This photo shows the precast concrete bands built into the brick wall. This is typical wall construction around the library school

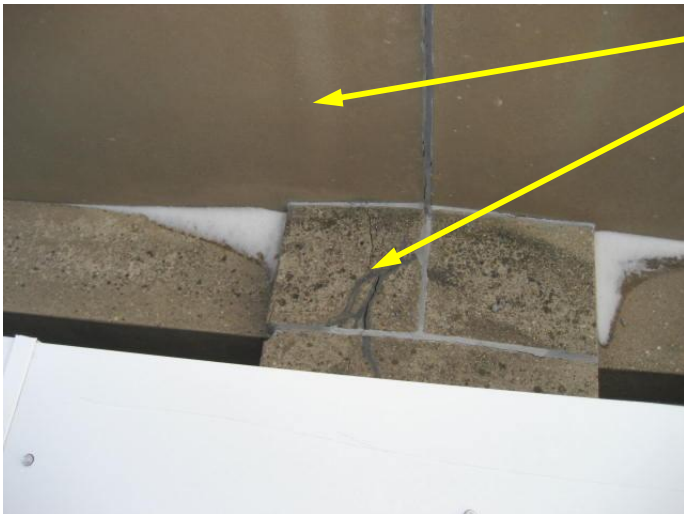
**Picture #27: East Side roof level –outrigger support of concrete spandrel**

10. Photo #27 shows the typical outrigger condition at the tower roof level. The wash slabs have in some cases cracked on their upper surface which can admit water to the concrete outrigger beam below. It is believed the wash conceals the panel connection below and any leakage would endanger that connection. We are recommending the washes be routed and caulked where the cracks occur.

Spandrel Panel-caulking in vertical joint is in need of replacement

Concrete outrigger wash slab. The cracks in the wash slab will need to be routed and caulked

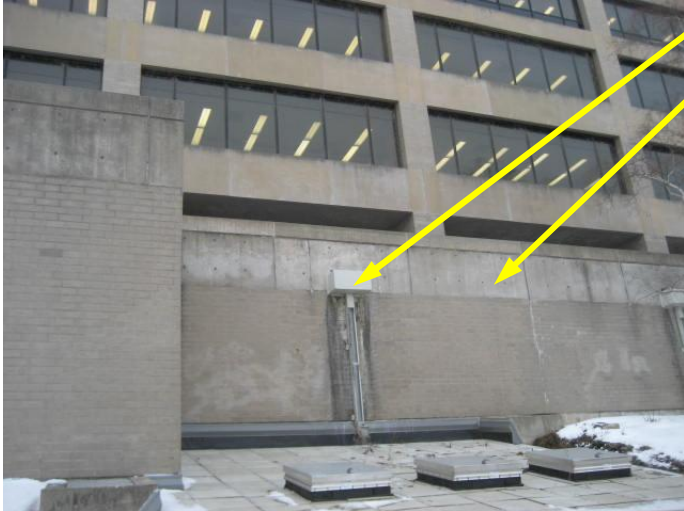
**Picture #28: North Wall at the walkway**

11. Photo #28 shows the north walkway scupper. The scupper was a concrete extension off the precast panel. This extension was not watertight and water was able to enter the brick wall below. This has caused the staining evident in the photo. The drain configuration was revised presumably when the walkway was repaired. This appears to be working successfully. We have reviewed the condition of the brick under the drain area and find it in reasonable condition with no repair indicated other than cleaning.

Walkway drain. This has been re-piped from original construction.  
Walkway surface beyond

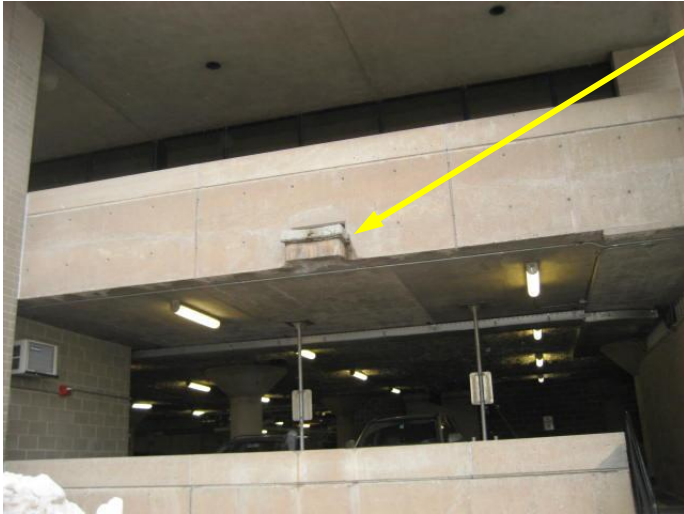
**Picture #29: East side walkway-paralleling Park Street**

12. Photo #29 shows the condition of the scupper at the east walkway. This scupper was constructed in a similar manner to the north walkway. There are two drains thus along this side. The north scupper is placed over a lower stairs and has a metal extension to keep the water from entering the stairs below. The south scupper has deteriorated over time and been repaired with grout over the top.

Deteriorated scupper with grout repair on the upper surface.

This is viewed as a short term solution with the desired repair being that as was done at the north walkway.

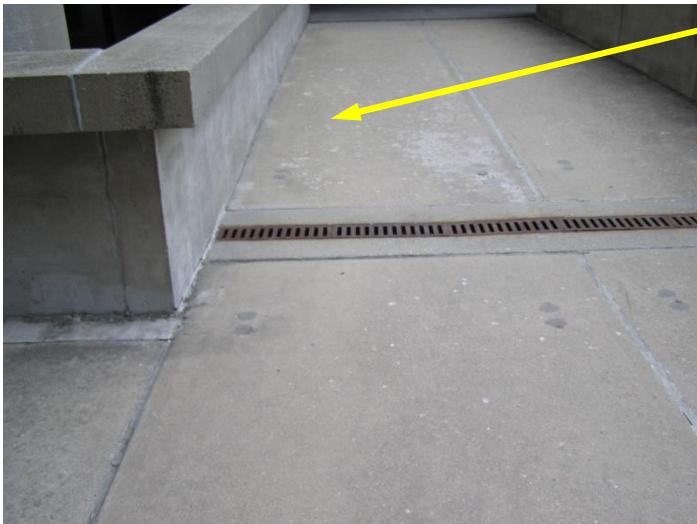
**Picture #30: Center Section of Walkway showing spalled panel**

Spalling is evident on this precast walkway panel. The remainder do not have similar problems

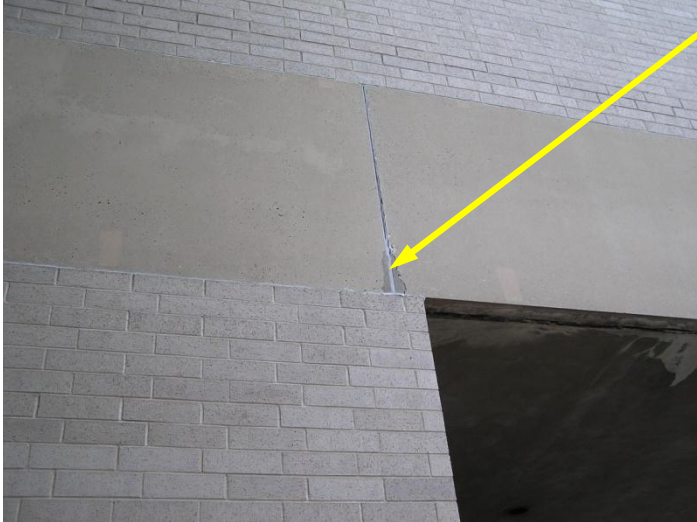
**Picture #31: East Side of Courtyard showing panel spall**

13. Photo #31 shows a cementitious patch in the precast panel which has become delaminated and occurs in several locations. We would propose the patch be removed and the area filled with caulk.

Corner of the panel has spalled. The repair has been pulled out by the caulking.

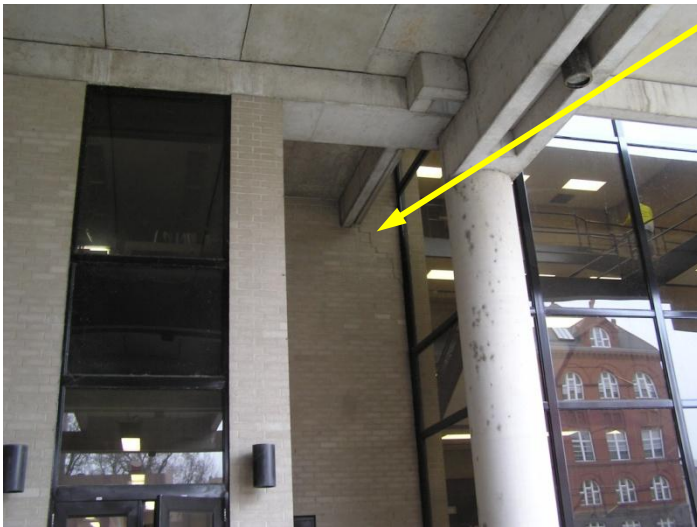
**Picture #32: South side of building at the entry to the elevators which service the tower**

14. Photo #32 shows a mortar crack in the vicinity of a small cast-in-place concrete beam. The beam is not believed to bear on the brick. The crack does not go thru any of the bricks. The repair proposed would be to re-point the joint with a matching mortar.

Step crack in brick at the poured in place beam bearing.

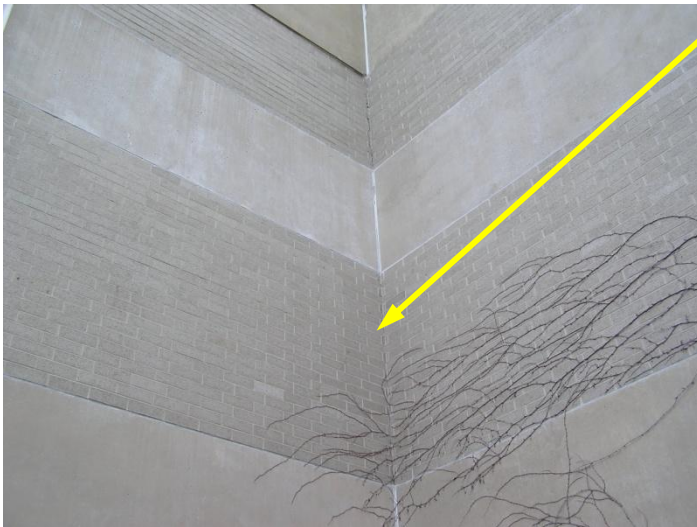
**Picture #33: Southwest corner of the Office Tower**

15. Photo #33 shows a vertical crack in the toothed-in re-entrant corner brick joint in the southwest corner of the office tower. The precast/precast panel re-entrant corner joints also have a heavy caulking to indicate this joint there has probably also opened. We would propose the brick joint be routed and a heavy bead of caulk be applied to seal the joint.

Cracked brick full height between precast panels

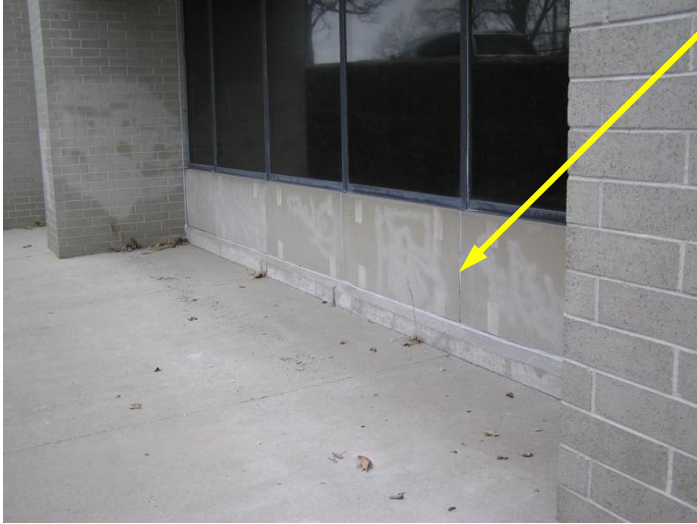
**Picture #34: West side of Office Tower at the base**

16. Photo #34 shows the precast panels below the windows along the west side walkway. These panels will need to be re-caulked in this and the similar circumstances around the west, north and east sides. The cost of doing this caulking is carried in that for the building in general.

Precast panel joints require re-caulk. This is typical along the west, north and east walkway.
