# HELEN C. WHITE LIBRARY FAÇADE EVALUATION UW Madison, Wisconsin

Submitted to:  
**Division of State Facilities**  
101 East Wilson Street, 7<sup>th</sup> Floor  
Madison, WI 53702

**Date: May 1, 2009**

**DSF Project Number: 07K3W**  
**A&O Project Number: 080362**

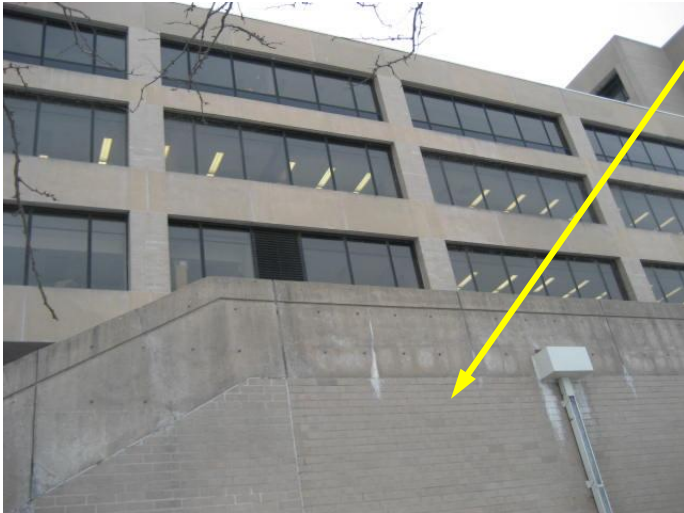
**Picture #9: North Elevation East End**

3. The north elevation of the building adjacent to office #4232 (fourth level east end of the library school building) has a crack as shown on photo #9. The crack extends from the end of the intersecting precast panel horizontally toward the window and into the exposed brick inside office #4232. This is most likely a result of initial shrinkage in the precast panel and exacerbated by thermal movement. There are no other instances where this occurs in the building leading to the idea that the repair would be simply re-pointing of the joint with matching mortar. There does not appear, from the ground, to be any broken bricks thus making the repair fairly straight forward.

Cracked brick at office 4232 Signal Tower
